# Guideline for Thermal Imaging

Issued by: Sustainability Department (Green Building Department)

Guideline No.: GB/009

## Title: Thermal Imaging

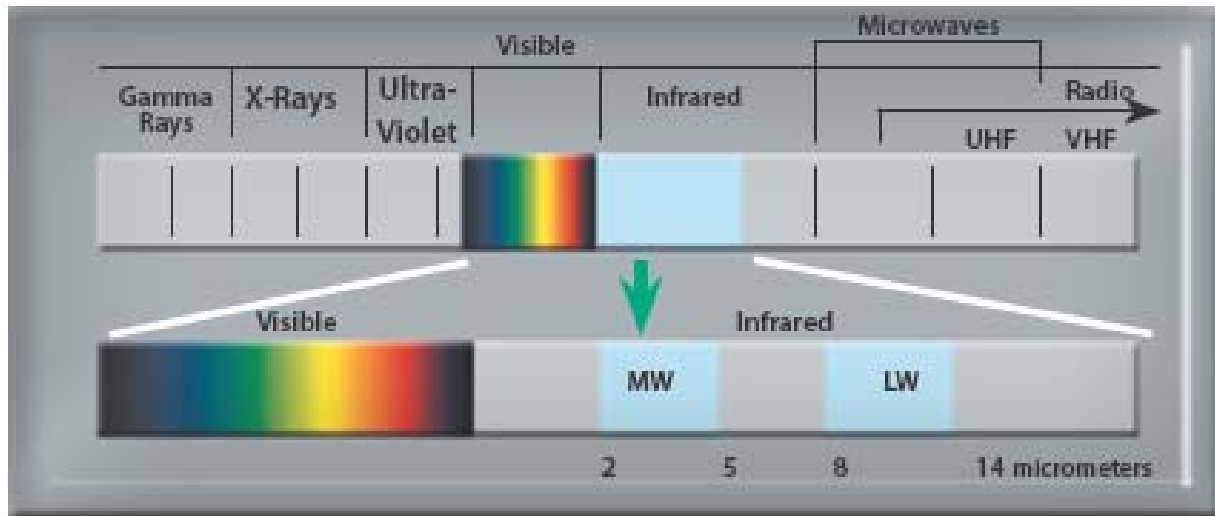
A typical electromagnetic spectrum is indicated below

Electromagnetic Spectrum

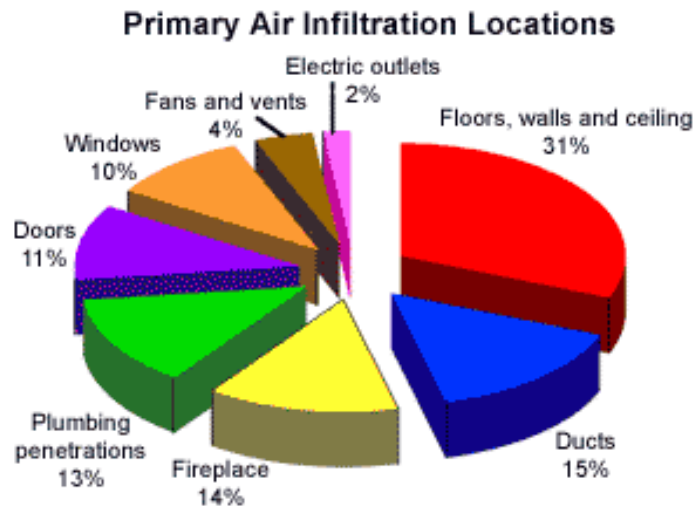
precious energy. This happens through leaky envelope, sub-standard construction, improper maintenance and other issues. The figure below shows the air leakage locations based on a study of buildings in Australia. While it is for illustration purposes only, the picture provides a broad perspective of the seriousness of the issue and more importantly its relevance to a place like UAE having a harsh environmental condition.

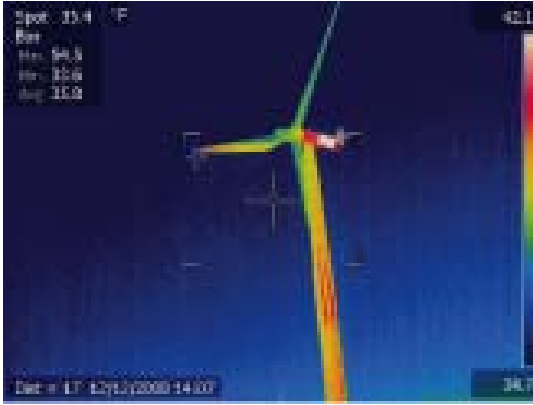
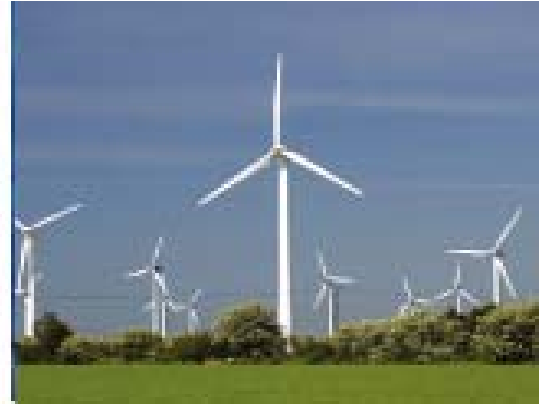
Thermal Imaging being carried out on Wind turbines

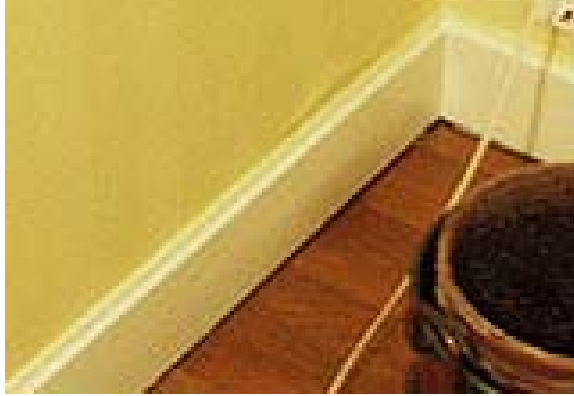
Detection and visualization of Infiltration / Exfiltration. Air leakage through the gap between the wall and the floor.

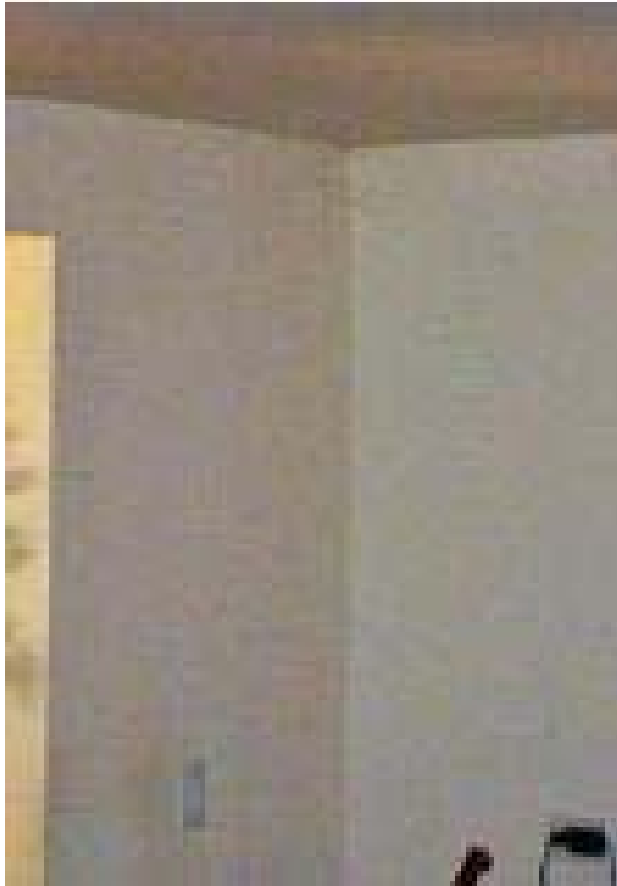
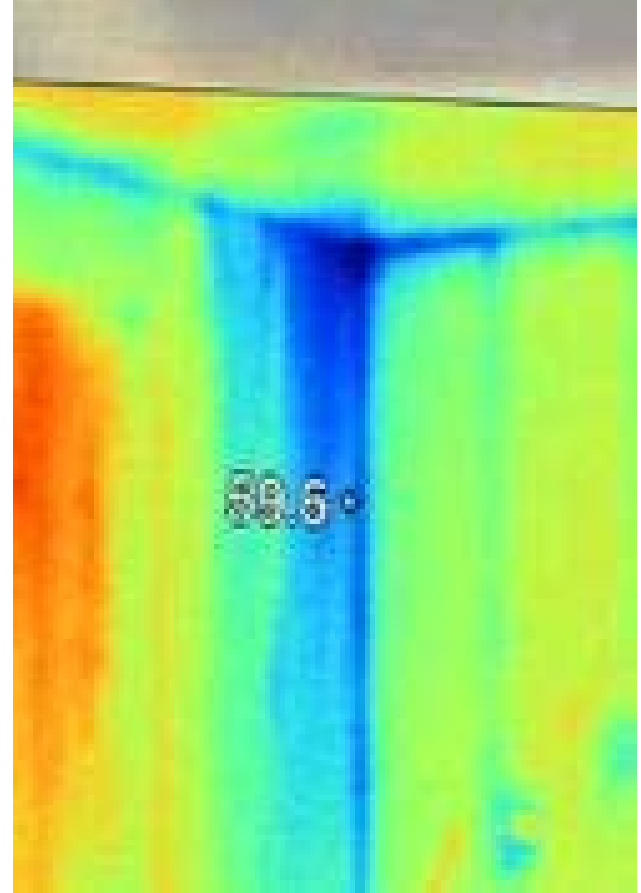
Water Behind the wall not visible to the naked eye

Water Behind the wall that has been captured by the IR camera.

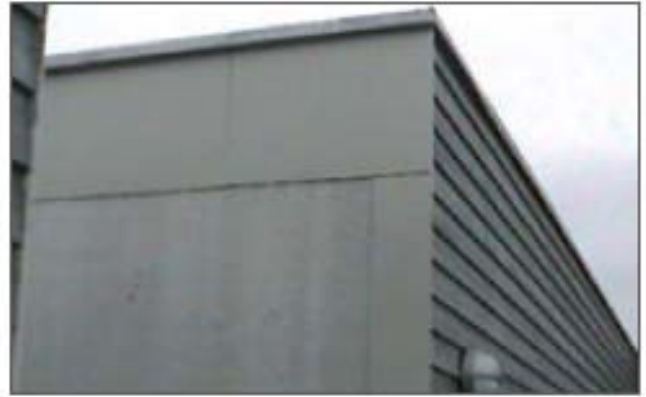
*This building is warmer on the inside. It is a sandwich construction, concrete - insulation - concrete. One section of insulation is missing which is not possible to see visually either from the inside or the outside. Here thermal imaging can see what the human eye can't.*

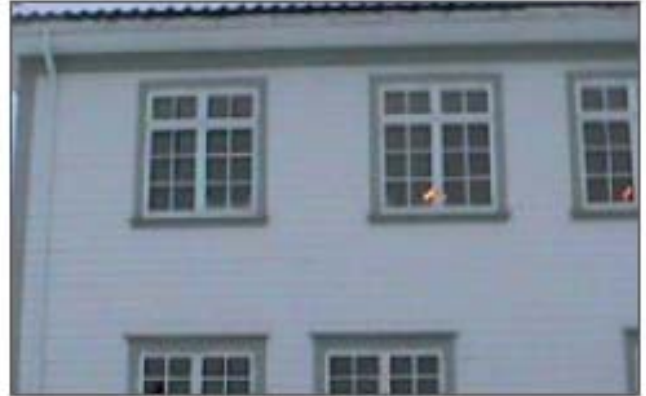
*Framework construction. Many of the sections are missing insulation as indicated by the warmer colors.*

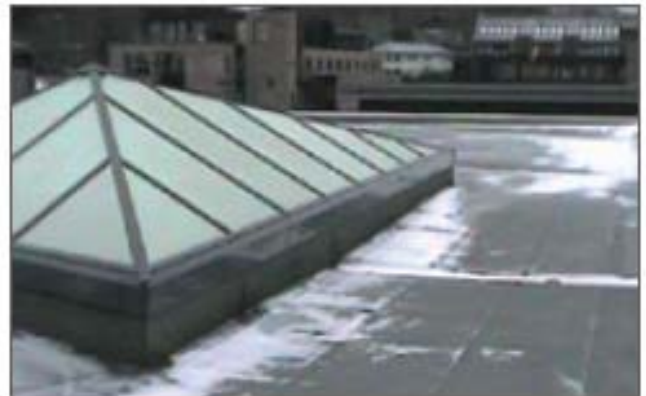
*Glass roof above an atrium. It is watertight, but not air tight. Warm air escapes because of the over pressure. The solution is to air tighten the glass roof.*

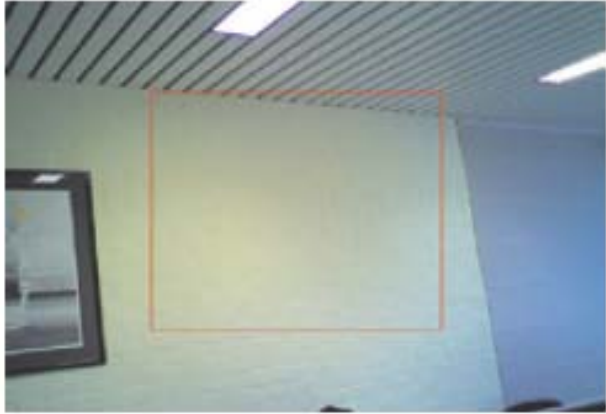
Thermal survey from outside, the thermal images clearly indicate poor or missing insulation.

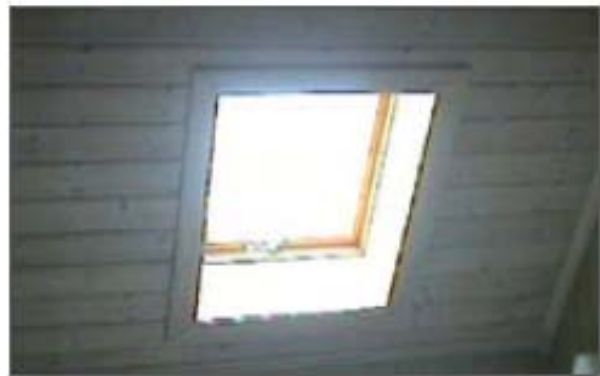
Image shows air leaks between the ceiling and the window.
